**FIVE-YEAR REVIEW
FINAL REPORT**

**LEES LANE LANDFILL SITE
LOUISVILLE, JEFFERSON COUNTY, KENTUCKY**

June 1998

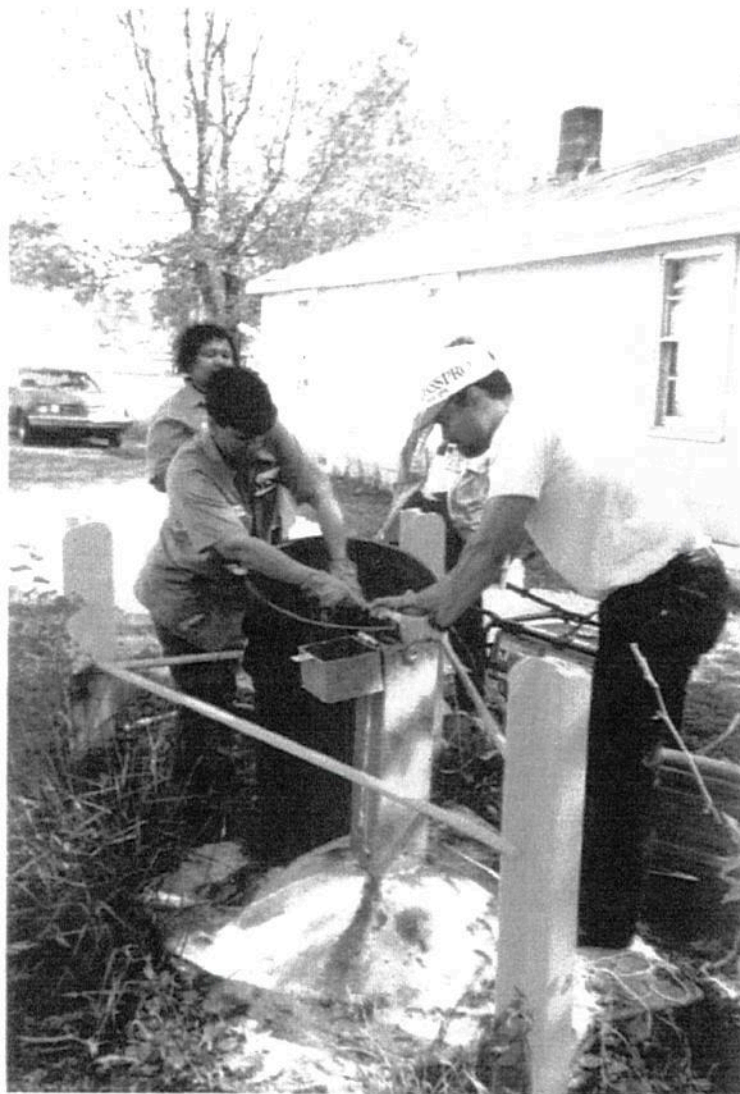
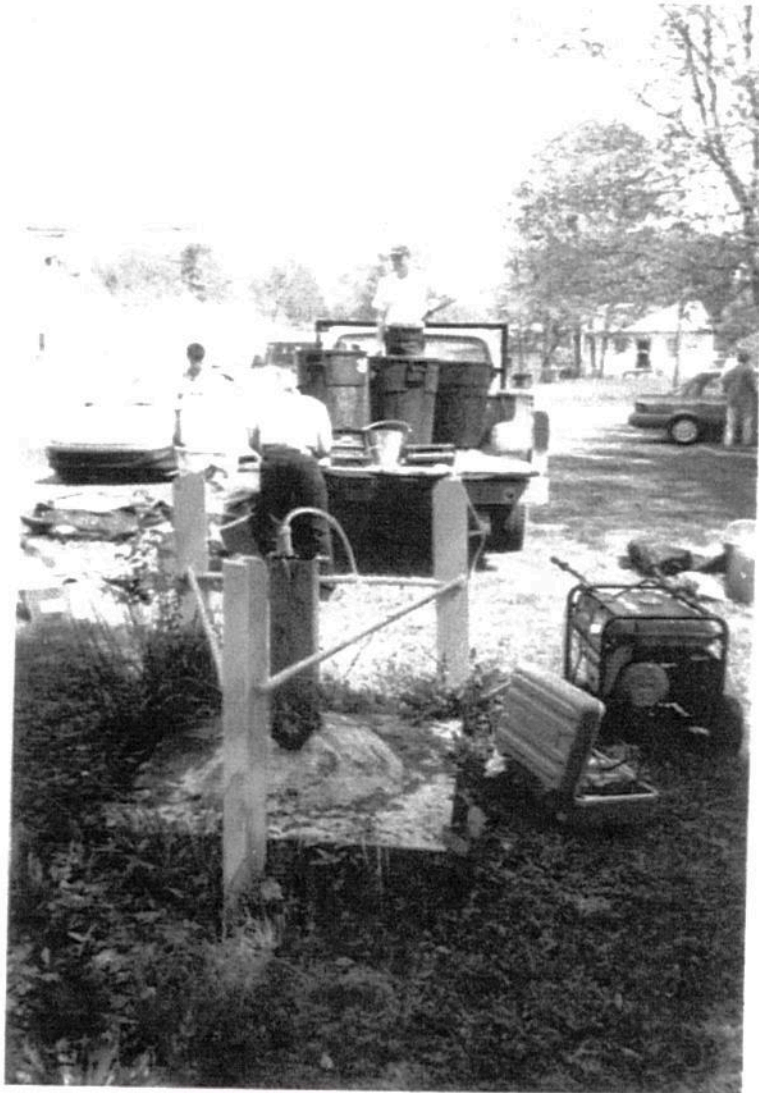
Photograph 24: Groundwater sampling at monitor well MW-A. Sampling was part of the quarterly monitoring program. Well protective casing and pad were in good condition and the well was locked during the time of the site review.

Photograph 25: Additional picture of sampling at monitor well MW-A.

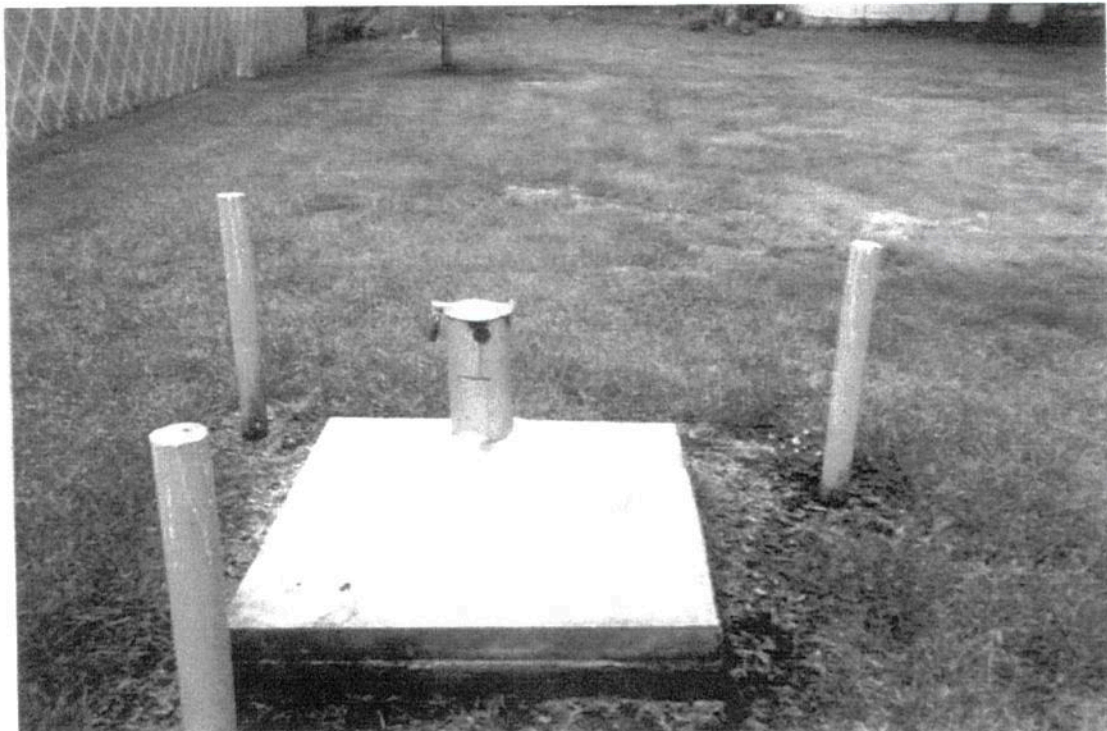
Photograph 26: Northeastern view of groundwater monitor well MW-02. Well casing and concrete pad were in good condition and the well was locked at time of review.

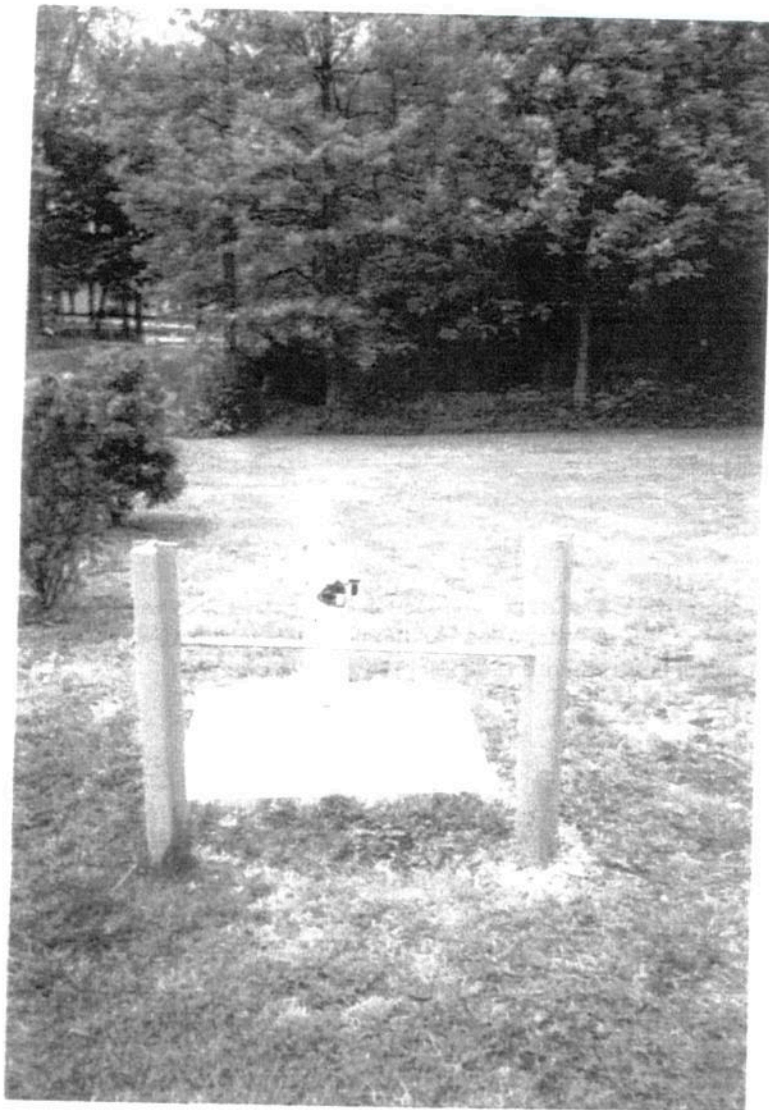
Photograph 27: Northeastern view of groundwater monitor well MW-B. Well casing and concrete pad were in good condition and well was locked at time of review.

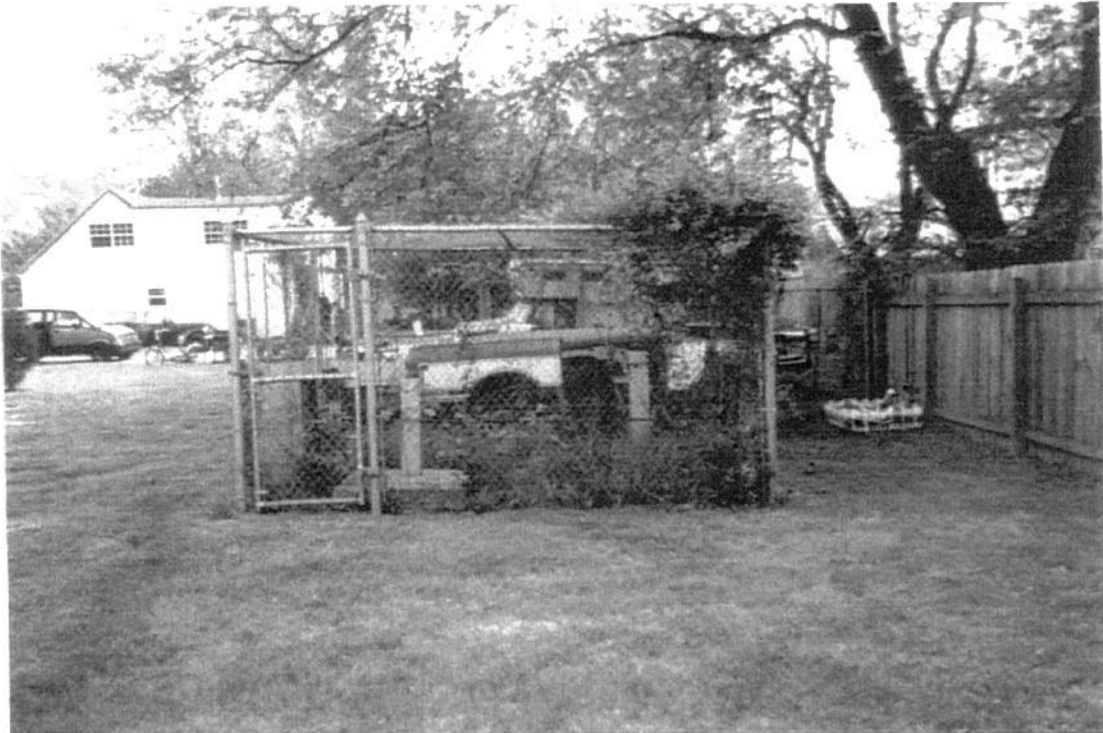
Photograph 28: Southeastern view of gas sampling wells G-5. Both wells were locked and concrete pads and protective casings were in good condition at time of review. Gate to enclosure was unlocked. Note growth of brush within and on top of enclosure.

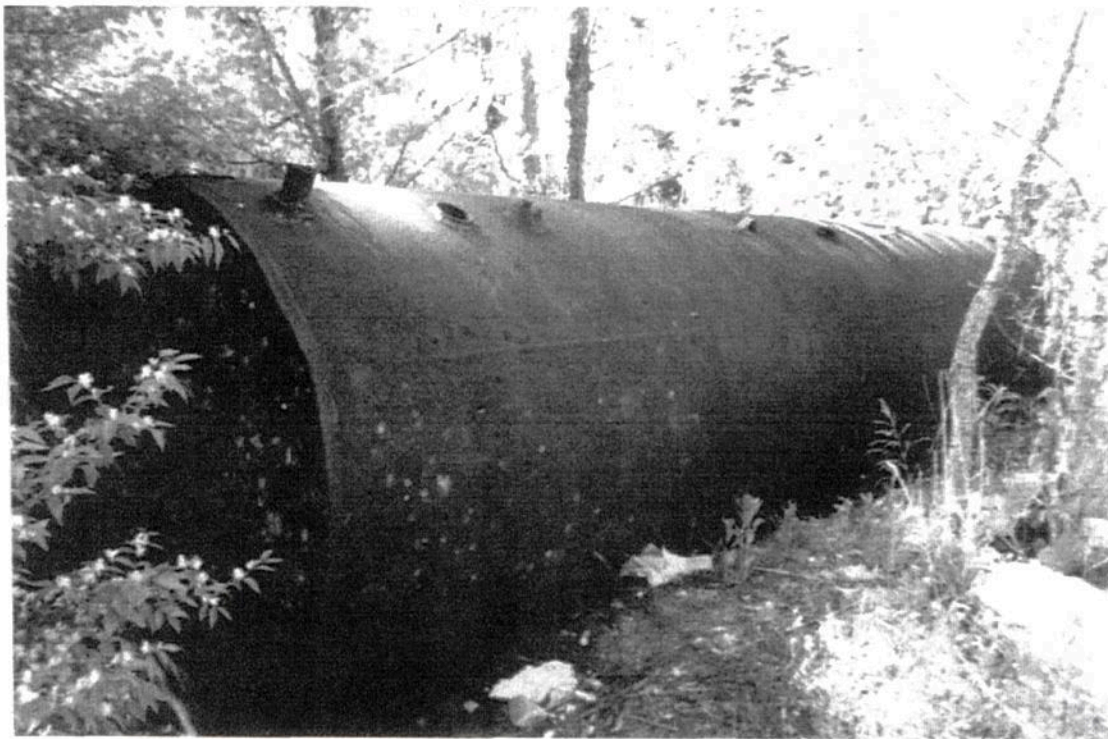
During the site review, the WESTON representative noted a rusted, bullet-hole-ridden, 20,000-gallon tank located near the former scalehouse location (Figure 2-1). Since the tank was partially buried and pipe connections were projecting from the tank, it is likely that this was an on-site underground storage tank during operation of the facility. Upon closer examination, some type of liquid was seen in the tank. A strong, petroleum-type odor was detected around the tank and emanating from holes in the tank walls. Photograph 29 presents a view of this tank. The western end of the tank was settled in approximately 2 feet of water.

Photograph 29: Southern view of an approximately 20,000-gallon tank near the former scalehouse and scales location. Numerous bullet holes were found in the entire tank. Visual observation of fluid was made of tank contents. Fluid within had a strong petroleum odor. Note moisture on bottom of tank in left-hand side of picture. Right-hand side (or western end) of tank was resting in water approximately two feet deep.

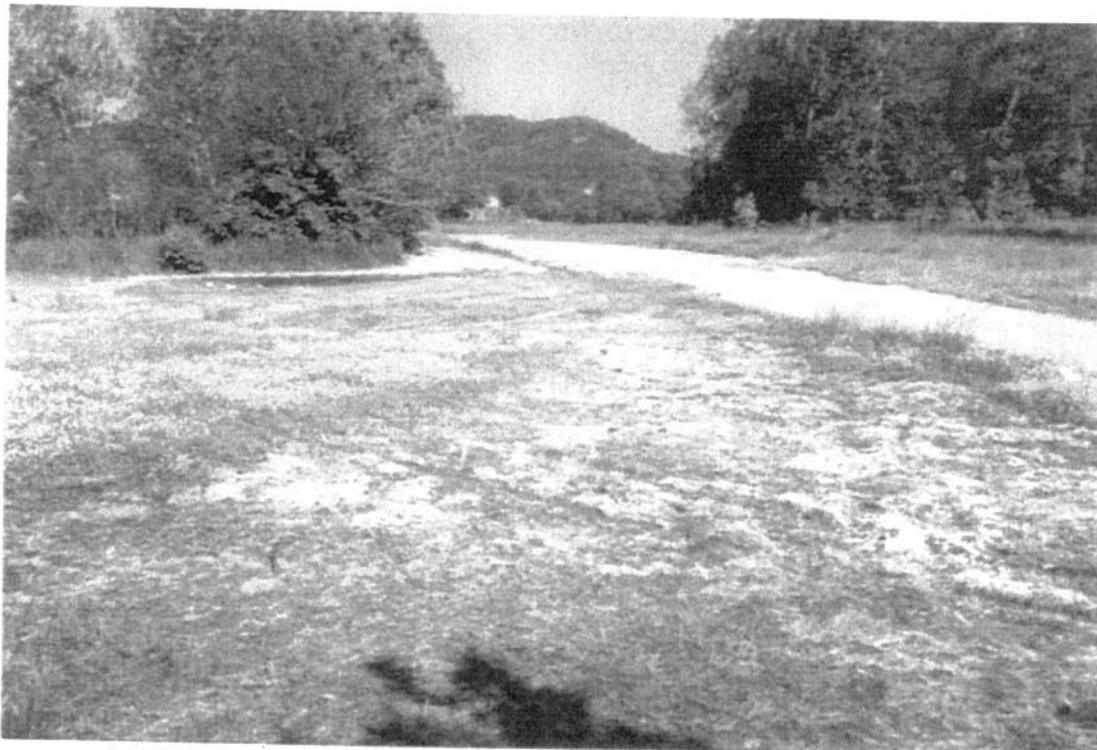
Photograph 30: Northern view of dead plant life zone that appears to originate from tank in photograph 29. The zone varied in width from approximately 8 feet to 35 feet. The overall length of this "dead zone" was approximately 150 feet.

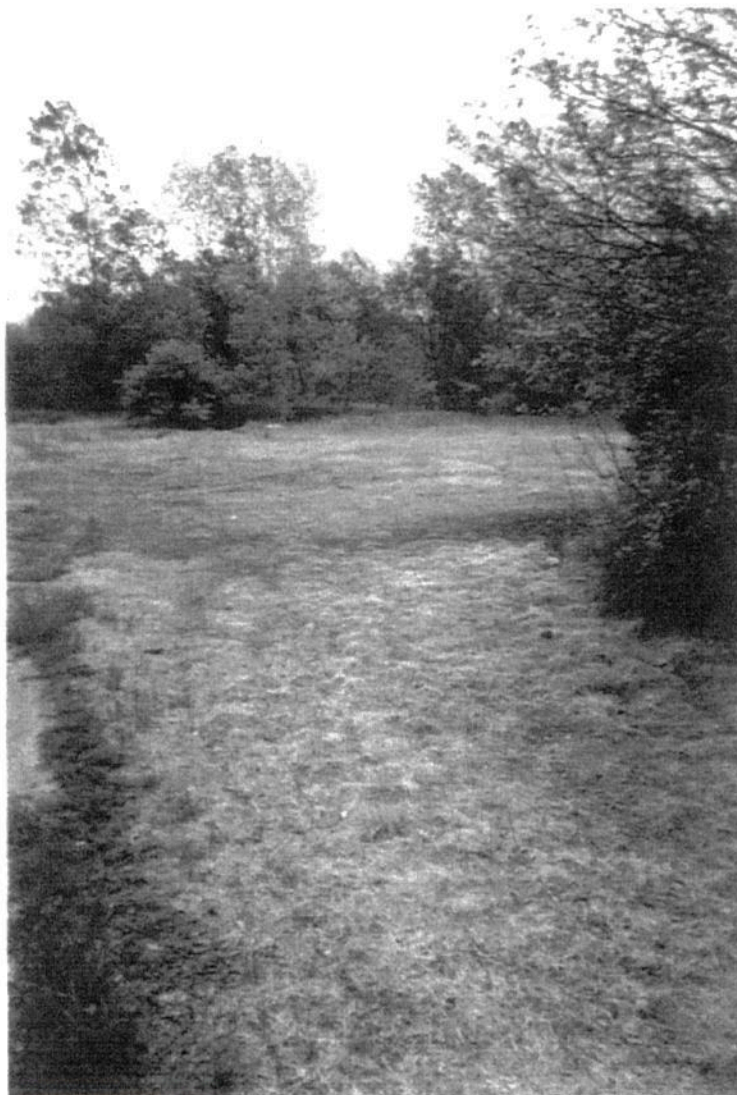
Photograph 31: Southeastern view of dead plant life zone leading back towards the tank in background of the picture. From photographer's view, the "dead zone" moved to the right (or west) and into a small drainage swale.
